DEPARTMENT OF TRANSPORTATION

OBG TRIAL ASSEMBLY

LIFT: 7-West -Panel Point (PP) #50~55.

WELDING INSPECTION REPORT

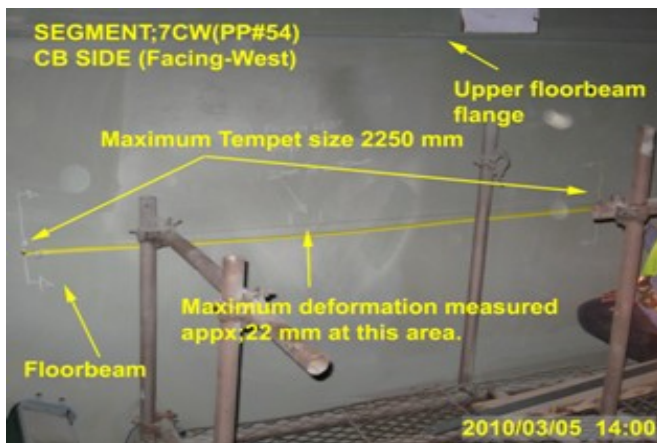
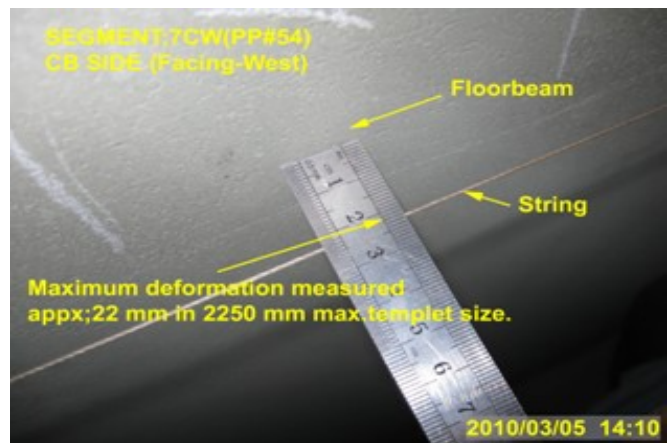
- The Deformation was measured to be approximately 22 mm in 2250 mm Maximum template size.
- The Segment and Panel Point no is 7CW-PP#54 Facing West at Crossbeam (CB) Side.

This QA Inspector performed dimension check for the longitudinal diaphragm weld length from the cope hole to the weld termination point for OBG Lift: 6 East from PP#40 to PP#47 at E3 Location along with Caltrans QA Inspector Mr. Manoj Prabhune. The measured readings were data recorded, generated the report and submitted to the Task Leader for further action.
